#### **Eastside Harvest House** Kirkland, Washington

# **Custom Home Case Study** 5-Star Built Green Home in Kirkland

### Eastside Harvest House - a bounty of sun, rain & food

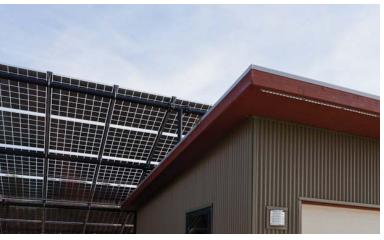
Single family residence treads lightly on its semi-urban lot with a large permaculture garden, solar power and solar hot water, and rainwater collected for interior and exterior uses.

One of the most sustainable homes in the NW region, Eastside Harvest House (EHH) takes advantage of abundant resources – sun, rain, good farming soils and climate. With a comprehensive, deep green design approach, this single family residence treads lightly on its semi-urban lot with a large permaculture garden, solar power and solar hot water, and rainwater collected for interior and exterior uses.

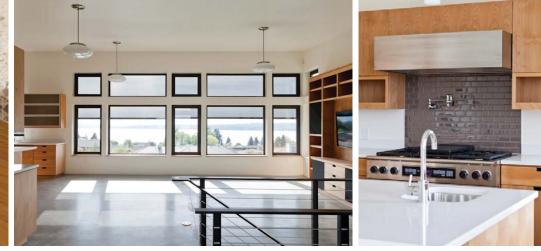
Photos Left to Right: Products with high recycled content used, No carpet and zero-VOC paints and low-toxic water-based sealants to improve indoor air quality, Formaldehyde-free cabinetry.

- Materials chosen for durability, ease of upkeep and high-recycled-content
- Materials and finishes include using 100% FSC wood
- Used low or no toxicity materials and finishes
- Minimum PVC used
- Products with high recycled content used
- Waste management deconstruction plan recycle rate of 98% of previous onsite structure (62% diversion after biofuel and alternative daily cover excluded)
- Utilized advanced framing techniques to reduce waste
- Post-consumer 100% recycled glass cullet was used under slab as a capillary break
- Used blown-in cellulose for insulation containing 85% post-consumer waste
- Durable metal roofing with 55% recycled content installed that has a 40-year warranty

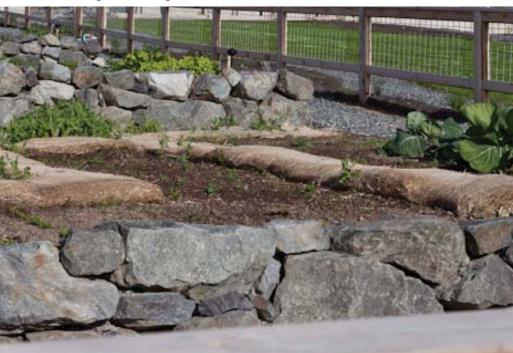
A series of terraced rain gardens are designed to infiltrate 100% of storm water on-site.

EHH hits some impressive performance metrics, starting from the ground up. A series of terraced rain gardens are designed to infiltrate 100% of storm water on-site. A dispersion field handles potential overflow and backup measure. In addition, four cisterns, with a total of 12,000 gallons capacity, capture rainwater from the metal shed roof. In its first summer, most of the collected rain water is being used to irrigate the landscaping during its initial establishment period. However, the filtration and UV sterilization system allow for subsequent use for interior potable uses, as well as toilet flushing and irrigation.
